U.S. CHEMICAL SAFETY AND HAZARD INVESTIGATION BOARD

INVESTIGATION REPORT

PETROLEUM PRODUCTS FACILITY INCIDENT

THIRD COAST INDUSTRIES

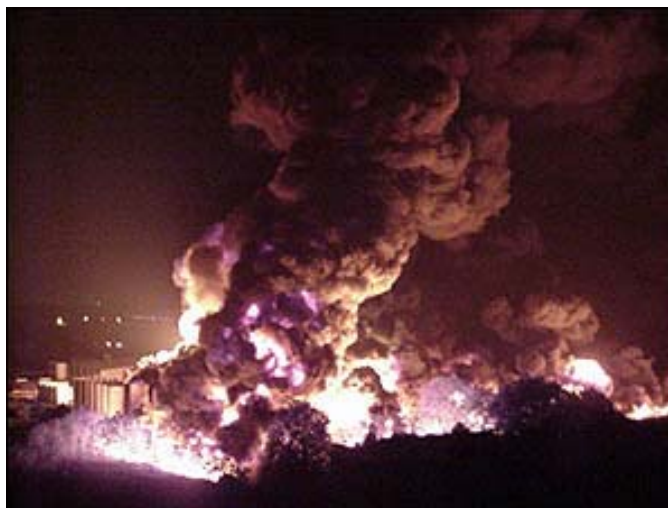
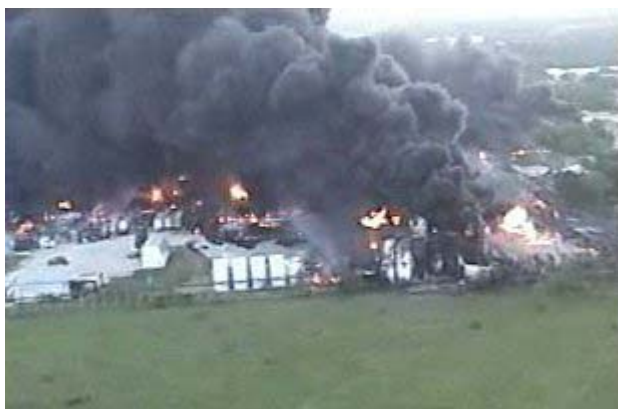
As the fire spread into the storage tank area, the liquid pool fire was also observed to move from the warehouse 1 area toward the front of the facility. This caused the fire to spread to a loaded box trailer and warehouse 2, and also across the southern property line into a neighbor's garage and machine shop. Over the course of the next several hours, the fire engulfed the entire tank farm and spread through warehouses 2, 3, and 4 (Figures 4 and 5)

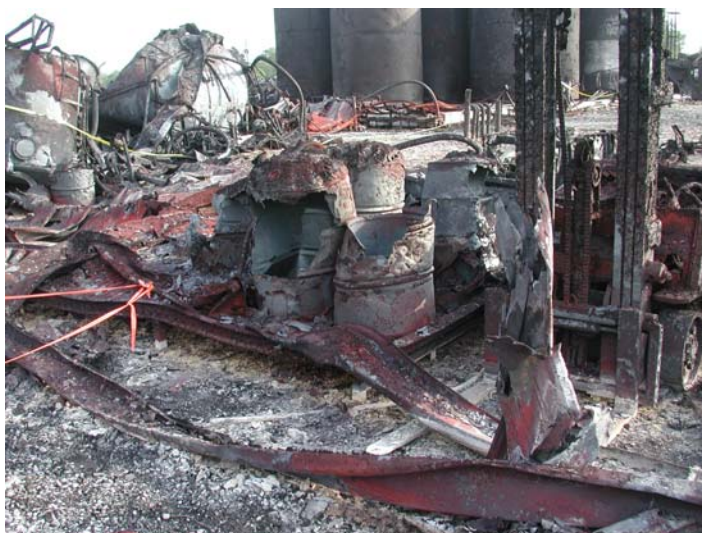
Figure 6. Drums located at packaging line 4.

Approximately 10 drums of combustible liquid were located on and around packaging line 4, just outside warehouse 1 (Figure 6). The drums would have loosely surrounded the worktable, where the security guard observed the initial fire. Evidence indicates that these drums ruptured due to internal pressure and released their contents, which subsequently ignited. The sounds heard by the Pearland Fire Chief upon his arrival at the scene were most likely caused by the drums rupturing.

The drums at packaging line 4 were standard metal drums without drum relief devices. A drum relief device is a plastic closure that melts during fire exposure and remains open, allowing pressure to vent. It is an option for flammable and combustible liquid containers. This mechanism protects the container

from failure, which would release the entire contents, and also helps prevent the risk of drums rocketing into the air and causing damage when they fall to the ground. Empty drums were found on neighboring property around the Third Coast site.

The Pearland Fire Chief's initial observation of a pool fire surrounding the box vans and the tank wagon indicates that the drummed material near packaging line 4 was likely the first large quantity of liquid involved in the fire. Steel drums exposed to a pool fire will typically rupture within 5 to 15 minutes due to the buildup of internal pressure. As FM describes: "The end result of a sealed drum exposed to fire is the violent failure of the container" (FM, 2000b). When the drums ruptured, their contents added more fuel to the growing fire and spread it faster.

The drums at Third Coast were not equipped with relief devices in their top heads. Relieving style containers vent internal pressure without initially releasing the liquid contents. Although consensus codes do not require that metal containers be equipped with relief devices, fire sprinkler requirements are reduced if containers are so equipped. If the Third Coast drums had been equipped with relief devices, it is likely that they would have largely vented pressure rather than rupturing. Although the devices do not prevent ultimate failure and release of liquid contents when exposed to a long-duration fire, they do allow

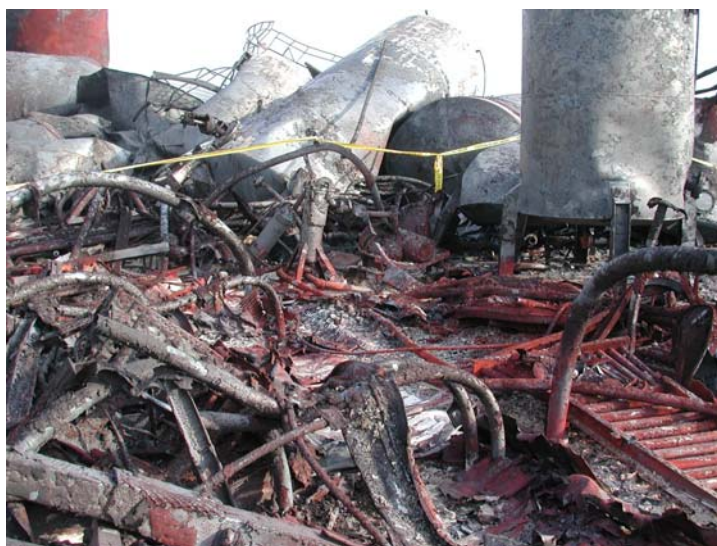
Figure 7. Collapsing blend tanks located near warehouse 1.

Several 2,000-gallon blend tanks were located to the northeast of warehouse 1. The tanks were supported about 3 feet above ground by steel legs with no external fireproofing. As the pool fire surrounded this area, the legs buckled and the tanks toppled and contributed their contents to the fire (Figure 7).

The blend tanks were located directly adjacent to the storage tank farm, separated by a low dike wall. In addition, numerous steel pipes from the storage tanks traversed the dike walls. Although pipeline valves were closed at the end of each pipe, the lines were typically not isolated with closed valves at the storage

tanks. As the pipelines failed due to fire exposure, they released material from the storage tanks that also contributed to the pool fire.

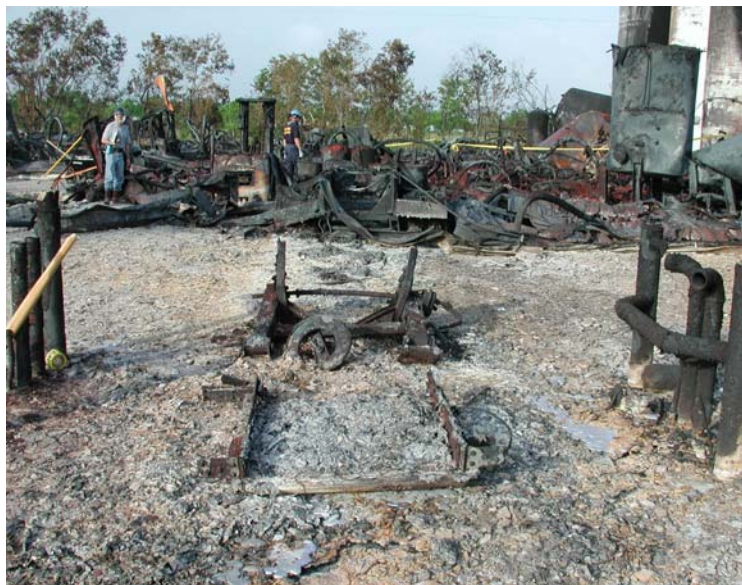
Figure 8. Remains of tank wagon, front end in foreground.
(Note pools of melted and resolidified aluminum.)

An aluminum tank wagon containing a combustible liquid synthetic motor oil (flash point > 400°F) was located within 6 feet of packaging line 4, where the security guard initially observed the fire. Third Coast was repackaging the material from the tank wagon into smaller containers for retail sale. The Pearland Fire Chief saw this tank wagon engulfed by the pool fire. The tank was venting, indicating that it was already being heated to a significant temperature.

In a fire of this type, aluminum rapidly weakens and melts. All that remained of the liquid compartment of the tank wagon after the fire were several pools of aluminum, as shown in Figure 8. The tank wagon's load of fuel contributed to the ground fire, which flowed toward the storage tanks and the warehouses.

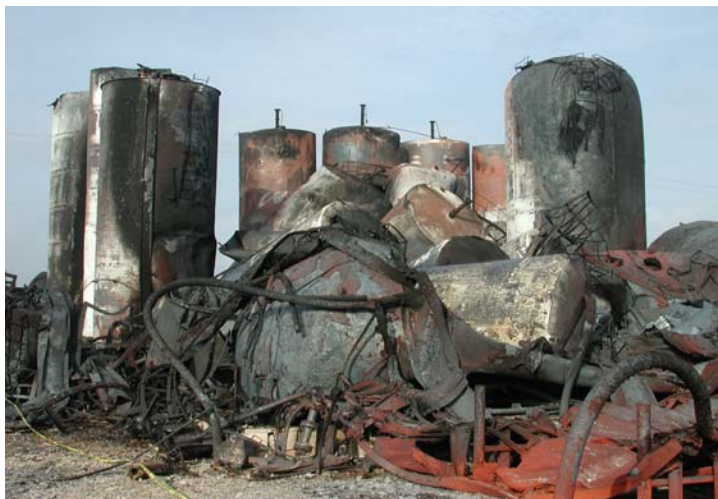
Figure 9. Failed storage tanks.

The Third Coast facility lacked adequate drainage or containment to prevent liquids released from the drums, blend tanks, and tank wagon from flowing toward the rest of the facility or offsite. The dike wall on the south side of the tank farm, closest to the fire origin, was composed of two courses of hollow cinderblocks. The cinderblocks were broken in places and mortared joints were cracked, which allowed the burning liquid to enter the tank farm and begin pooling around the storage tanks. The intense heat from the fire caused the bulk storage tanks to fail, either by overpressure or collapse; the burning containerized combustible liquids stored inside destroyed the warehouse buildings (Figures 9 and 10).

The storage tank areas at Third Coast were not designed to limit the spread of a fire. The tanks did not have relief devices suitable for external fire scenarios. As a result, rather than venting to the atmosphere, the tanks catastrophically ruptured and released their contents. NFPA 30 and OSHA 1910.106 require that aboveground storage tanks have emergency relief venting in the form of construction⁵ or a device to relieve excess pressure caused by an exposure fire (NFPA, 2000; 2.2.5.2.1).⁶

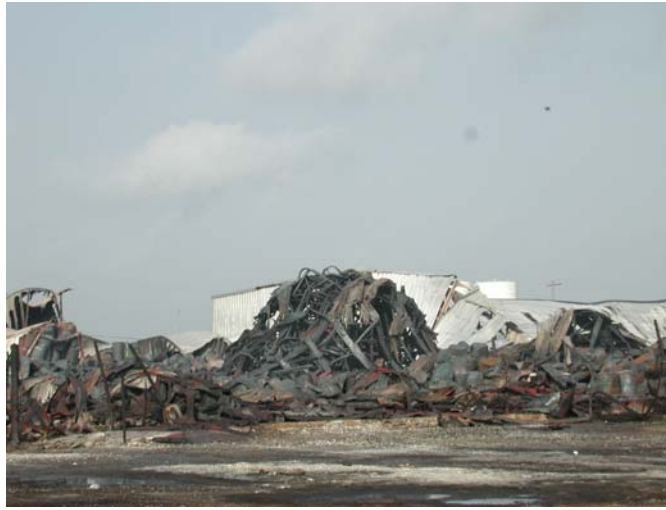
Figure 10. Remains of warehouse

The warehouse walls at Third Coast were constructed of corrugated metal. It is likely that they would have lasted only 15 to 30 minutes before failing. As a result, the fire quickly breached the warehouse walls and moved through the facility.

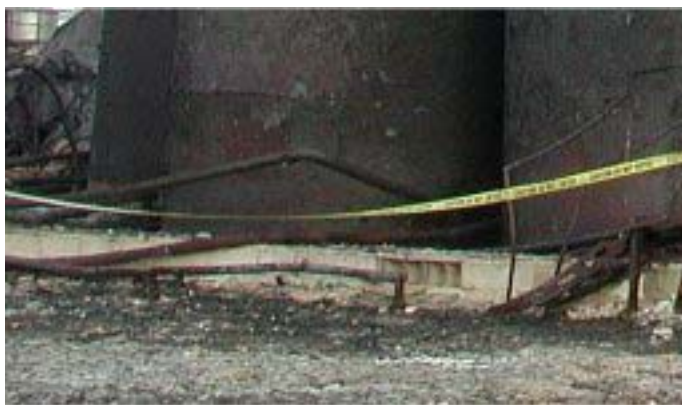
Figure 11. Storage tank farm section of south dike wall.

The storage tanks were located within 1 foot of the dike wall; in the vicinity of the initial fire, the wall was composed of two courses of hollow masonry cinderblock. The wall was in poor condition and cracked in some spots (Figure 11), which facilitated spread of the pool fire. Because of the proximity of the tanks to the wall and processing areas, radiant heat from the pool fire would have begun to heat the contents of the closest tanks.

- Inadequate design and construction of diking around the storage tank farm allowed burning liquid to breach the dike and pool around the storage tanks.
